**ATTACHMENT 5**  
**RIPARIAN DEMONSTRATION**

## Attachment 5: Riparian Improvement Demonstration

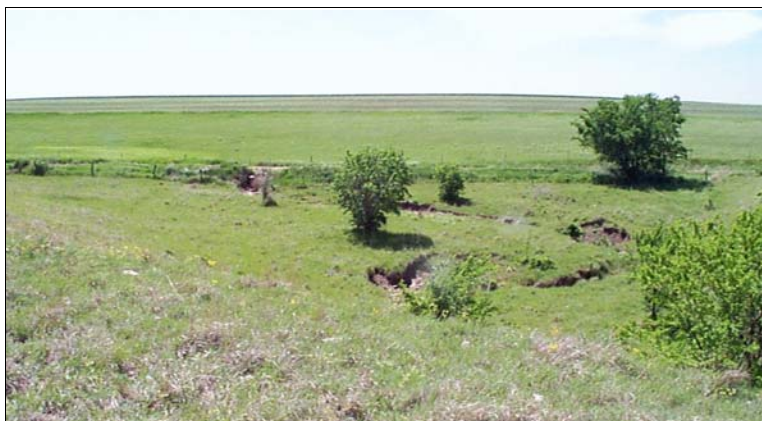
**Figure 2.** Stream channel entering pasture from the west, immediately below road culvert.

Beginning at the upstream portion of the stream, channel incision and hedge encroachment is first evident below the culvert where the stream enters the west side of the pasture (Figure 2).

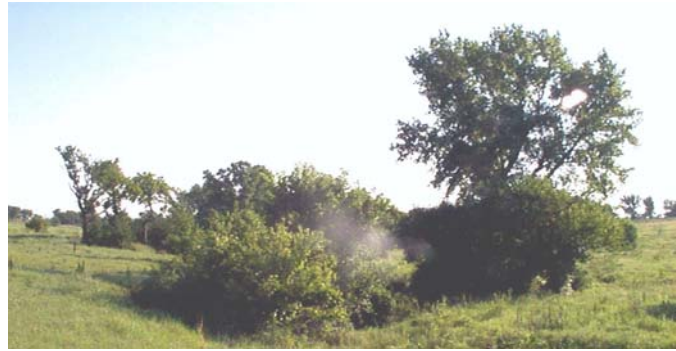
**Figure 3.** The remaining riparian area is at the south end of the pasture. (View looking north)

The current riparian area begins at a spring located near the cottonwood on the right (Figure 3). In the past another down-stream spring supported stream flow and riparian conditions. Dying cottonwoods on the left mark the location of the former spring. Hedge trees such as those in the foreground were out competing species needed for riparian functioning such as willows, cottonwoods, native grasses and sedges.

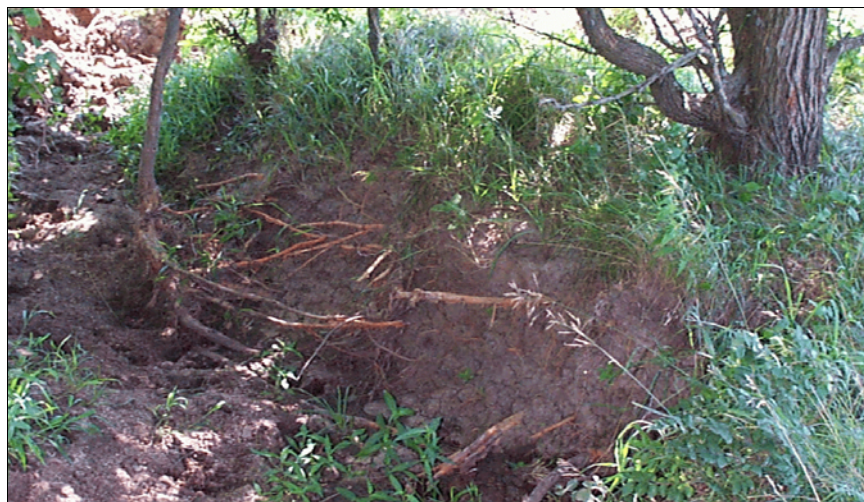
**Figure 4.** Rooting structures and streambank erosion.

Upland hedge trees are ineffective in stabilizing stream banks and preventing a stream from first widening and then becoming more incised. Notice in Figure 4 how the orange roots of the hedge tree on the right extend laterally toward the stream, and how the channel has widened due to streambank erosion. The rooting structure of riparian species that established at the waters edge have better streambank stabilizing properties. Notice how roots of the sapling on the left are growing back into the stream bank and helping to prevent erosion and stream channel widening.

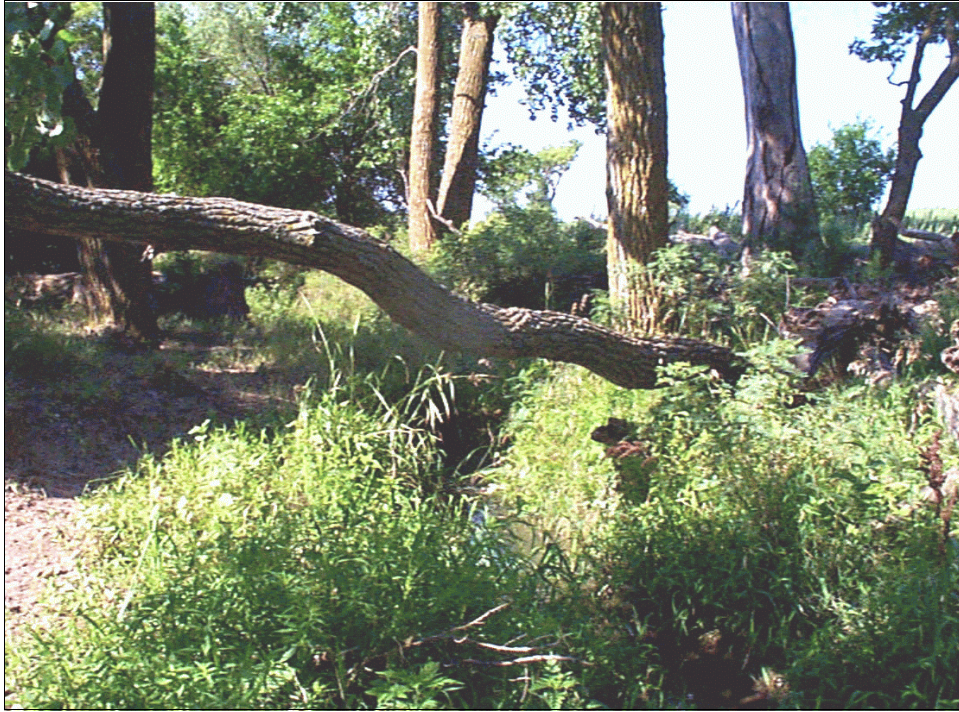
**Figure 5.** Dying cottonwood trees and declining riparian condition.

Farther down stream cottonwoods are dying (likely due to hydrologic changes) and being replaced by hedge trees that provide shade which is more desirable to

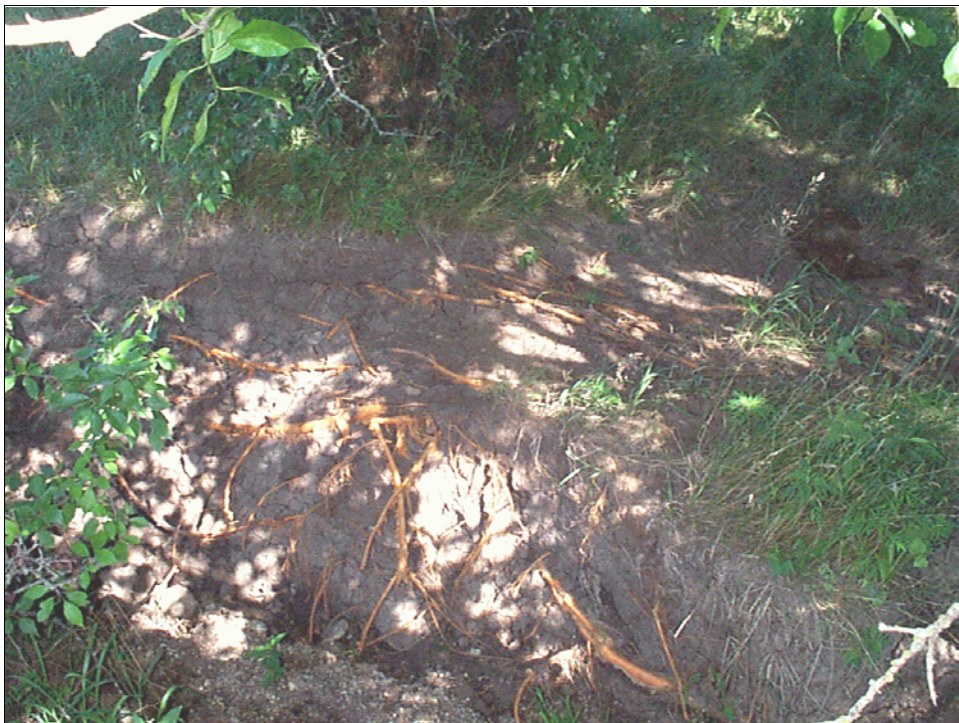
**Figure 6.** Eroding stream bank and livestock trail

livestock. The hedge trees are competing with grasses in the riparian community for light, water and nutrients. Range condition in the riparian area is declining from this and increased livestock use because of shade availability. Over grazing, trampling of vegetation, and trailing are contributing to water quality concerns in the riparian area (Figure 5). As livestock trail to the pond for water, stream side soil is exposed to the erosive affects of runoff and high stream flow events (Figure 6).

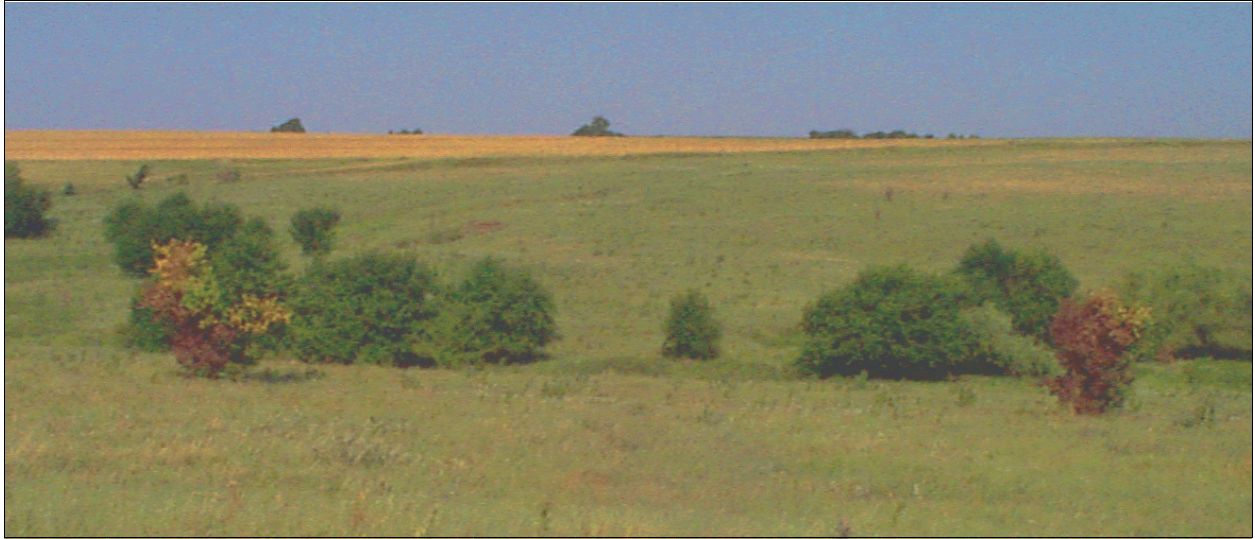
**Figure 7.** An early attempt by the cooperator to control hedge trees using foliar herbicide.

An attempt by the cooperator to control upland hedge trees using spot-treatments of foliar applied herbicide had less than optimal results. Neither of the two trees shown in the foreground of Figure 7 were completely killed following spraying. Notice the area of green remaining on the treated trees.

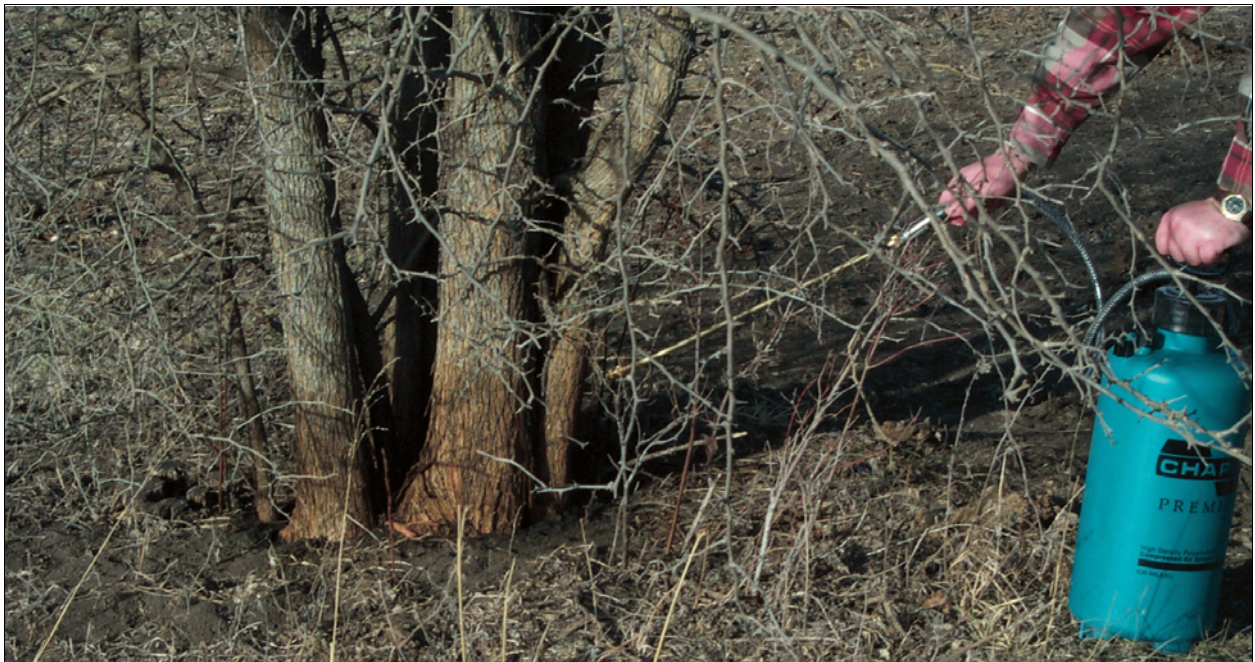
**Figure 8.** Basal bark technique for controlling invasive woody species.

The cooperator was introduced to woody species control technique called basal bark treatment (Figure 8). Basal bark control involves applying herbicide directly (targeted) to the trunk of the tree. From a management perspective, this treatment method is highly recommended over broadcast spraying except where dense stands of undesirable species exist on prohibitive terrain. However, from a water quality/environmental perspective, basal bark, frill & girdle, and spot treatments are always preferred relative to broadcast (aerial or ground) treatments. This is because broadcast treatments: impact non-target species, rely on one treatment method (chemical) instead of integrating (chemical, biological and/or cultural) controls, fail to account for changes in invasive densities, and usually result in the application of more control (especially chemical) than is necessary.

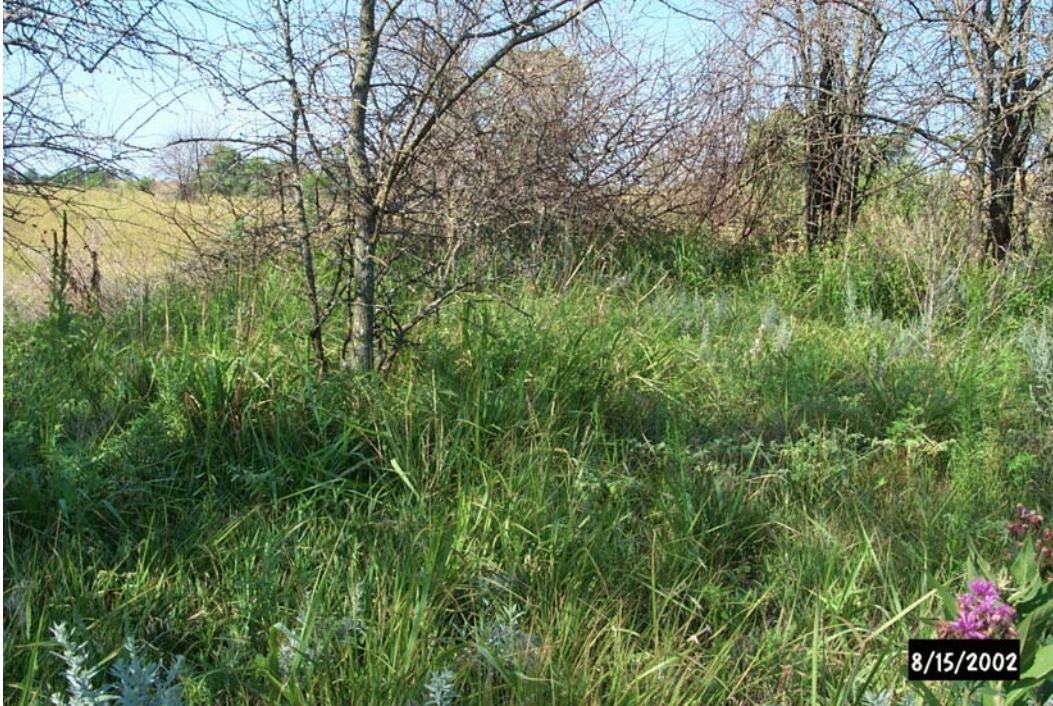
**Figure 9.** Control of hedge trees has improved cover due to reduced shade.

Plant regrowth following basal bark treatment of hedge trees was considerable despite drought conditions (Figure 9). Controlling the hedge trees reduced the shade canopy which reduced livestock use of the area and exposed remaining grasses to increased sun light. Controlling the hedge trees also reduced the competition for nutrients and soil moisture. Continued control of hedge trees in lowland range site/riparian area will promote plant succession returning to a riparian community where hydrologic conditions are suitable. Note the abundant false indigo bush in the flood plain shown at the right of Figure 10.

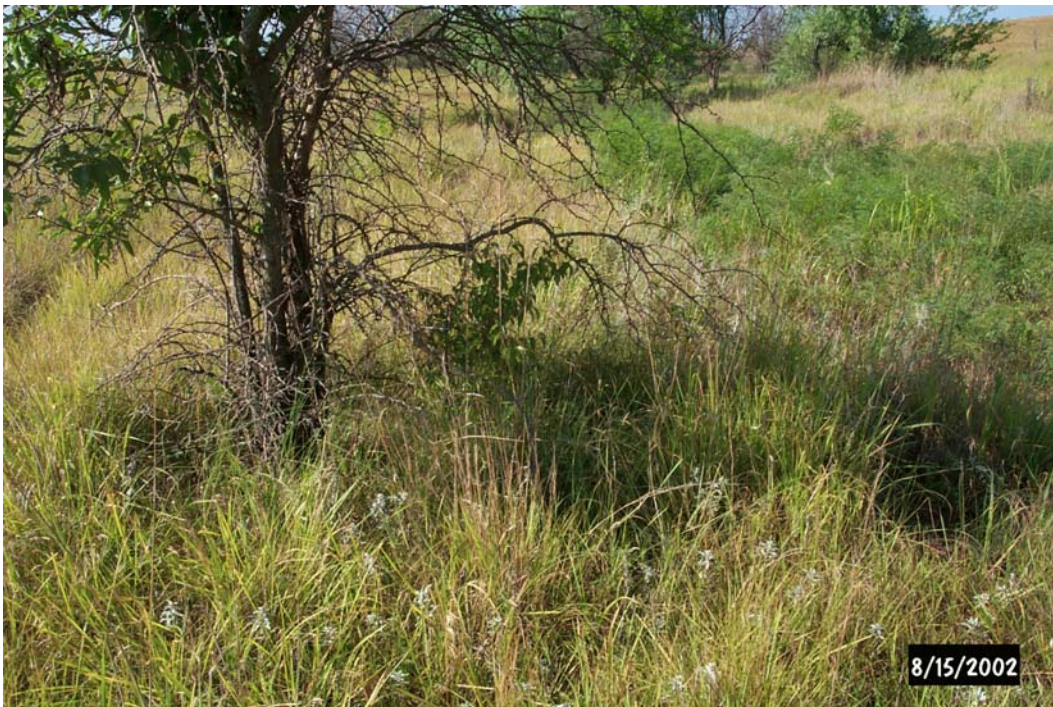
**Figure 10.** Desirable species are increasing in lowland and riparian sites.
